## Management of Vertical Crown Fracture with Post and Core:A Case Report

Dr. Ruchi Gupta<sup>1</sup>, Dr. Nivedita Saini<sup>2</sup>, Dr. Geetika Sabharwal<sup>3</sup>, Dr. Ayan  
Guin<sup>4</sup>, Dr. Shaik Muzammil Taj<sup>5</sup>

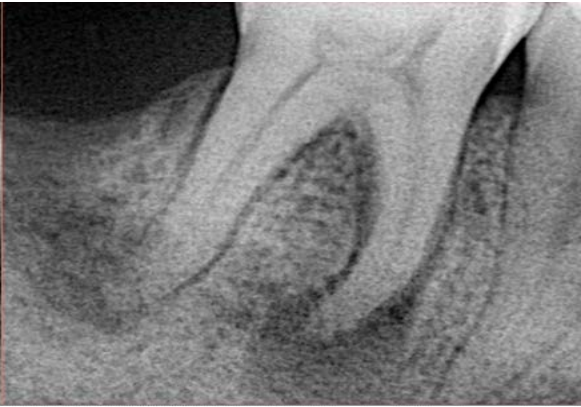
Figure 2: Pre operative radiograph showing periapical radiolucency

A 38 year old male patient came with chief complaint of pain in lower back right tooth region since 1 week ,clinically there was no evidence of caries in the coronal area .On radiographical examination ,periapical radiolucency (figure 2) was seen.

Treatment plan of root canal therapy followed by crown was advised.

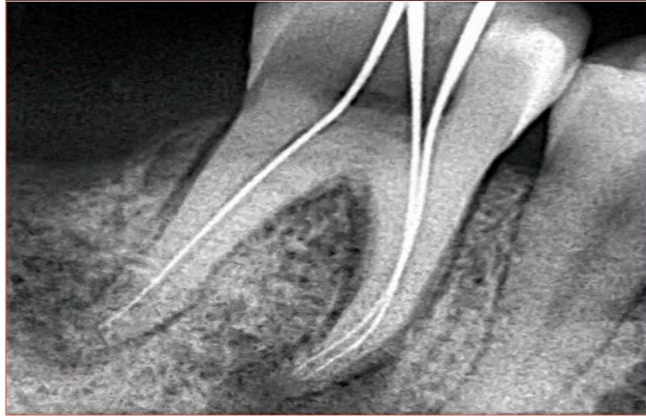
**Figure 3: Working length**

After removal of the broken fragment (figure-5) ,the access cavity was refined ,the orifice were located and enlarged with orifice shaper. Working length was determined with help of apex locator and radiographically and three canals were located - distal, mesiobuccal and mesiolingual (figure 3).BMP was done by protaper gold (dentsply) followed by copious irrigation by 3% sodium hypochlorite and 17%EDTA . After this temporary material was placed and patient was recalled after 3 days.

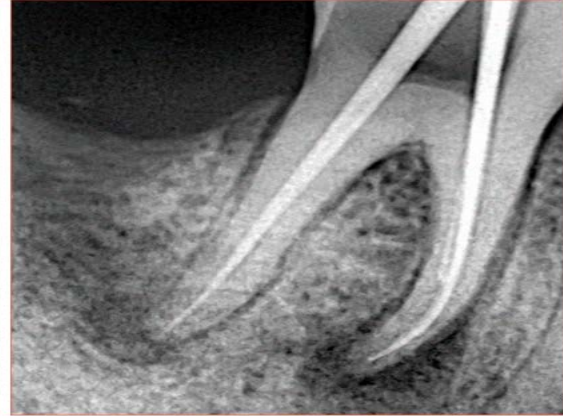
**Figure 4: Master cone**

Now, master cones were placed, tug back was confirmed and the rvg was taken to confirm the proper fit and working length. After, which the obturation was done with calcium-hydroxide based sealer (apex seal).

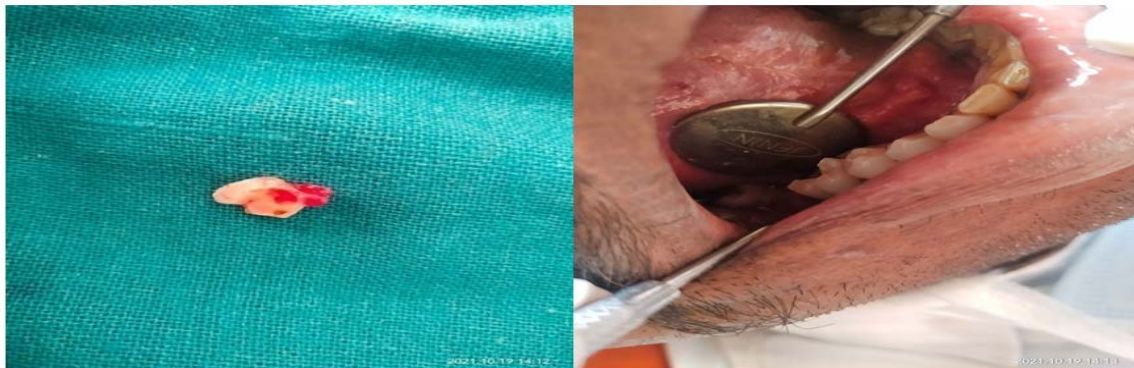
**Figure 5: Broken fragment and clinical view**

Endodontic therapy was initiated with the access opening of 46 ,however during the access opening , a vertical fracture was seen in the coronal portion ,which was not noticed prior to the initiation of root canal treatment.

The fracture extended below ,till the roof of pulp chamber .Now , because of the vertical

fracture the changes were made in treatment plan .the broken fragment were removed by the help of forcep.

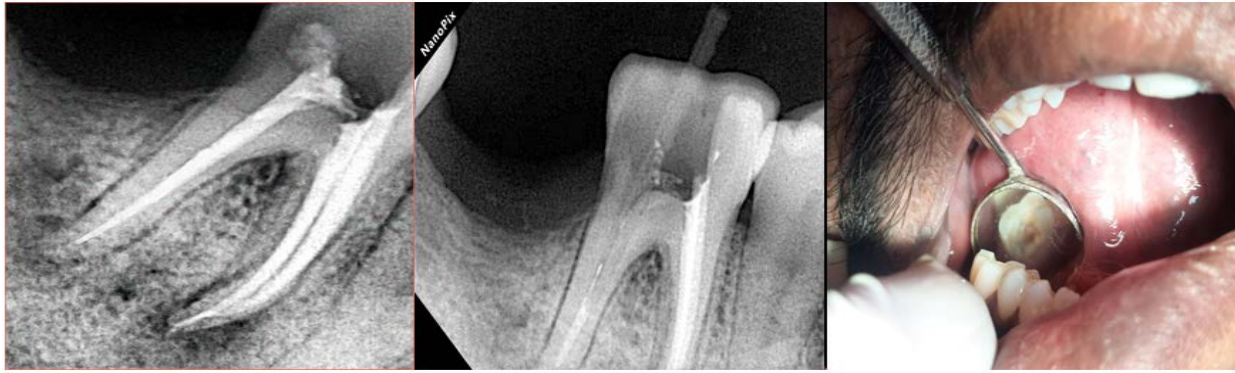
Figure 6: Obturation Figure, 7: Placement of fibre post after creating post space, Figure 8: Fibre post placed

After obturation it was decided to provide post and core to patient as tooth structure was compromised, the distal canal was prepared for the fibre post.

Post space was created by the help of peeso reamer #2 and 3. Length of the post space was 12mm and the entire working length was 20mm. The fibre post was placed and the fit was checked with help of an xray. The canal was irrigated and dried. and a thin, uniform coat of bonding resin cement (prevest) was applied over the post and thinned further with a slight air stream. The post was carefully seated into the canal using light pressure. The marginal seat was reaffirmed. The post was light-cured in place for 1 min on all surfaces. Core build-up was done with the help of composite resin.
